# **Site STUDY OF roman POOLS' SITE**

**Partnership project for the rehabilitation of  
cities for economic development**

**Preparation team the Local Development Unit and  
the Geology researchers**

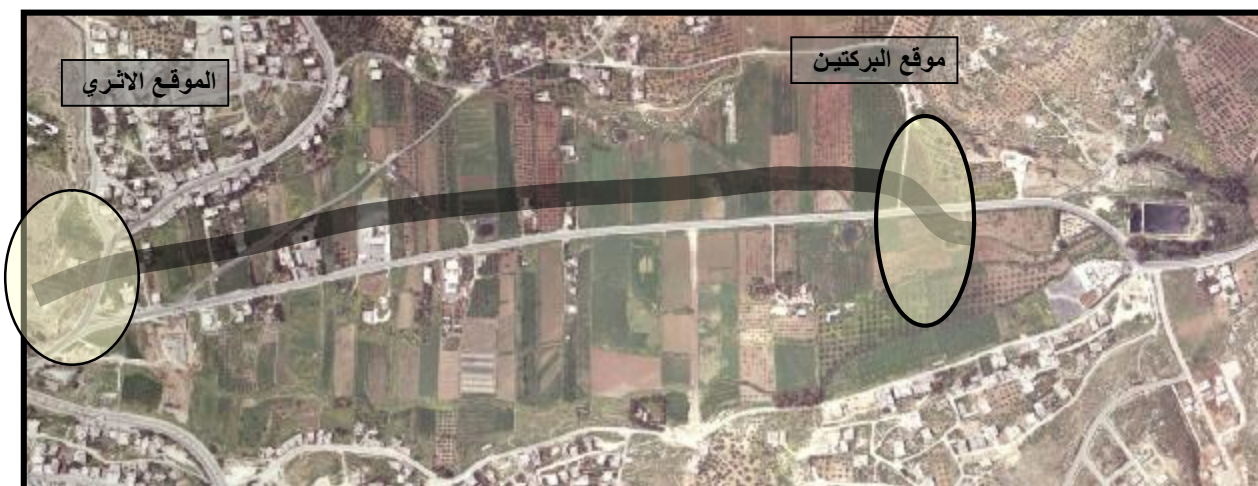
The site of the pools on an area of 12.323 acres backed by all the public services of water, electricity, roads, sanitation, and the site just in 1200 to the north of the north gate of the ancient city of Jerash and is accessed through a clear path from the north gate.

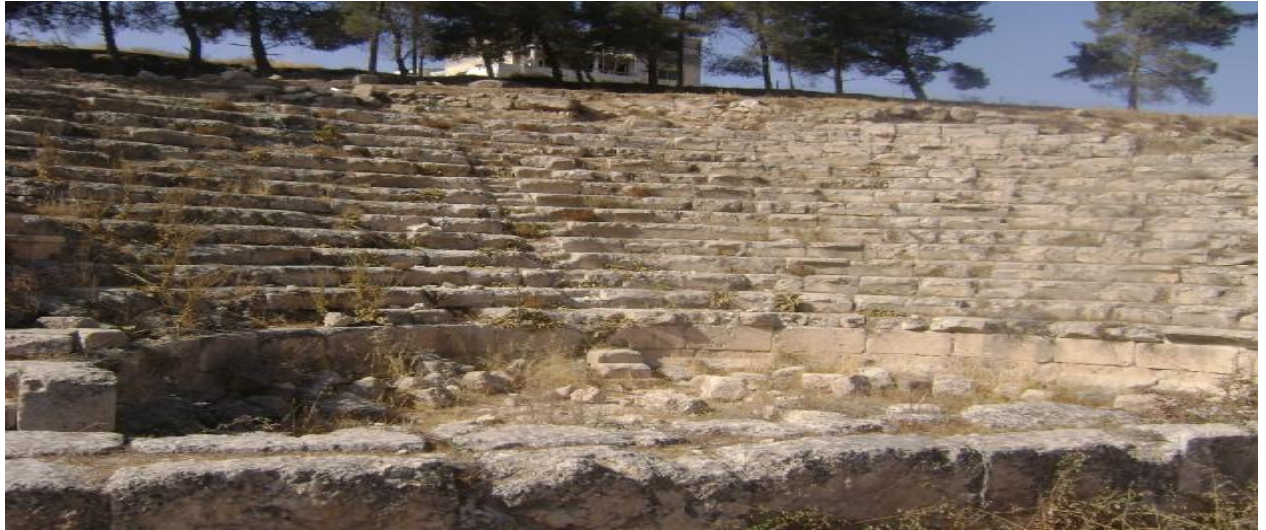
this theater had Been building on a semi-circular on the western slopes overlooking the pool, and the stones were used in the reconstruction of sections different of the theater are harsh limestone available in the region, it is quite clear "that the area and the size of this

theater much less of the area and the size of the north and south theaters in Jerash archaeological city.

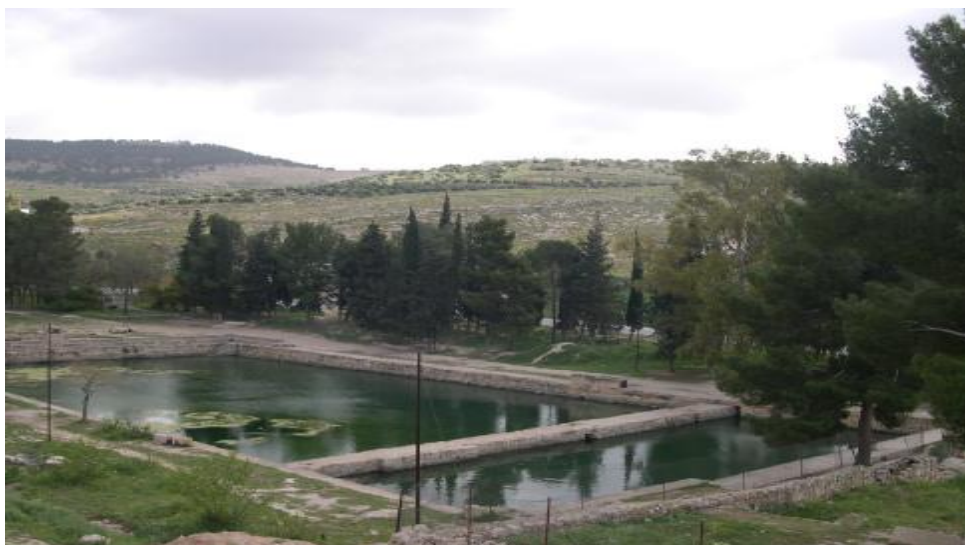
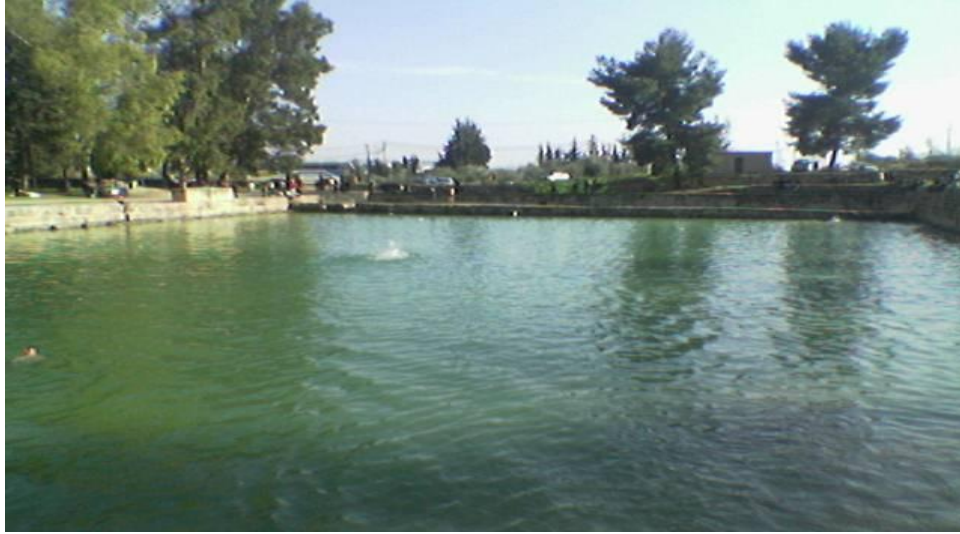
It is a rectangular pool, except the southern end of the eastern section, where its slightly tilted towards the east, that for possibility of control, and increase the flow of water towards the stone channels that relating to the pool of the south wall.

Its dimensions is (45.88 × 89.55 m) and at a distance (17.96 m) of the southeast corner there is the barrier with width (2.17 m), from the east, and at the end of the west side becomes (2 m), and the length of the wall (45.88 m) at a distance ( 4.76 m) to the west, we find splitter in the wall with width (80 cm), and that for water passage between the pools, after this splitter at distance (9.5 m), a gate to control the water flow away

The building materials used were of local limestone hardened, and some with jagged edges and other soft and irregular in shape.

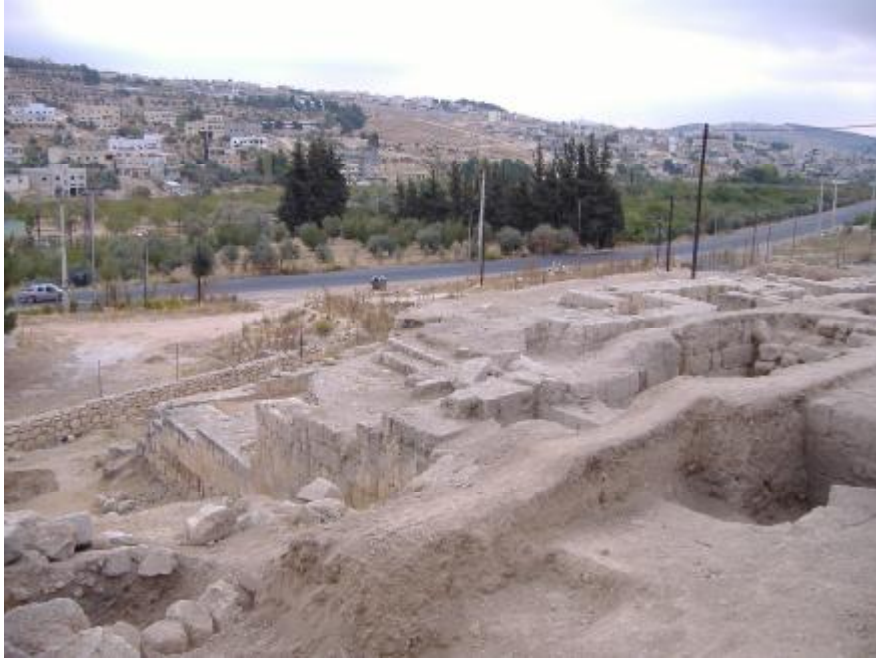
1 - Detection of Roman bathroom walls and its entrances, consists of three rooms in a row, namely: -

A – cold bathroom ( frigidrium)

B – warm bathroom ( Tepedarium )

C – hot bathroom (Caldarium )

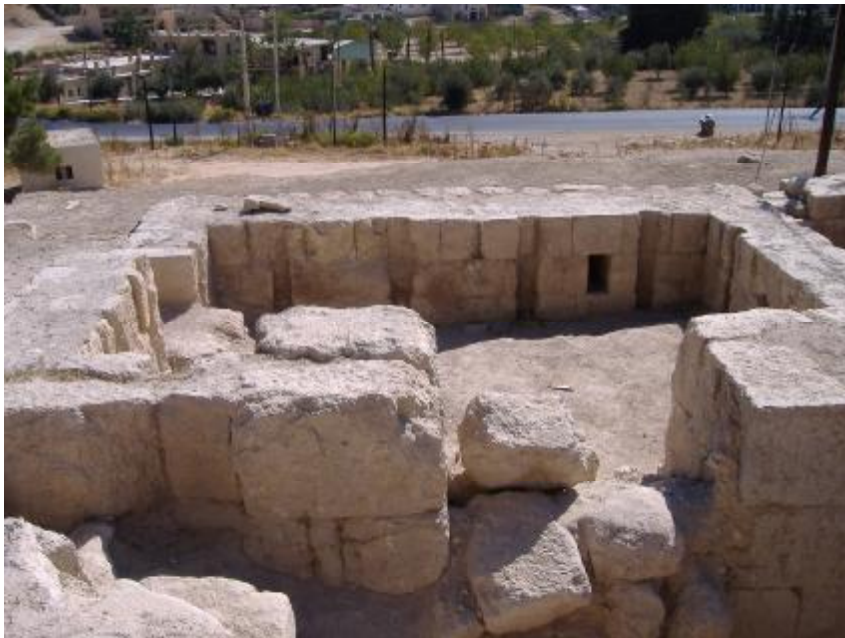
2 - detection Umayyad ground composed of medium-sized stones and trimmed.

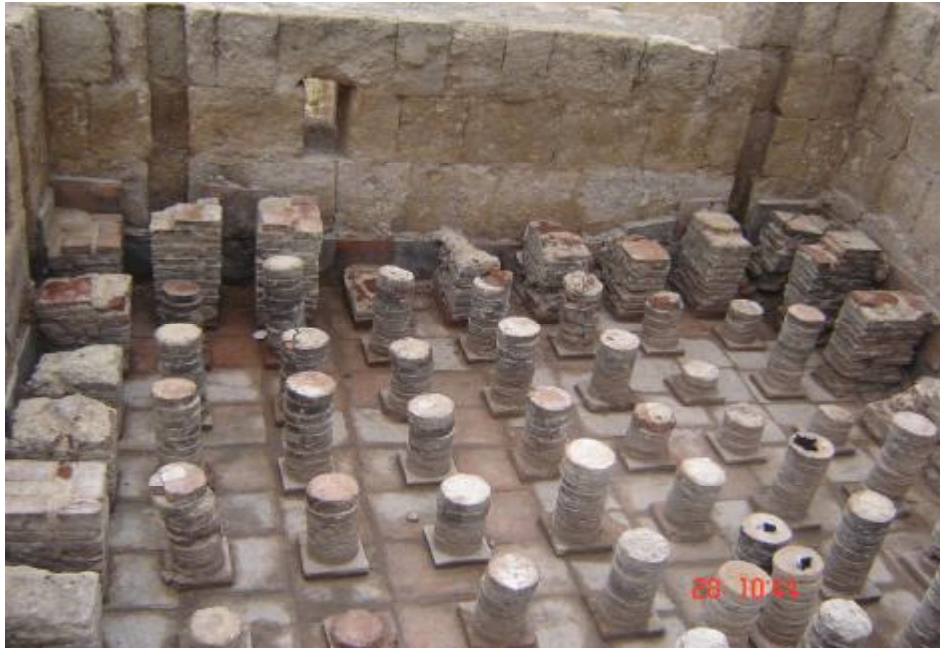
12 - drilling in the room No. 4 and found to represent the main room in the building of the bathroom (room hot) and dimensions of 5.9 m × 5.45 m was detected columns are built from disks brick circular which was held on the floor of the brick box shape, and on the sides have been built terraces are boxes Of brick small size, these terraces are isolated from each other has left, including spaces narrow and uneven, and during exploration and was found showing that the columns were covered by the (underlying) floor tiles, pottery of dimensions 56 cm × 56 cm and a thickness range from 5 cm approximately was found on one of the Broken tiles, but completed three broken when compiling.
